TECHNICAL NOTE 2538

MECHANICAL AND CORROSION TESTS OF SPOT-WELDED  
ALUMINUM ALLOYS

Fred M. Reinhart  
National Bureau of Standards

Washington  
December 1951

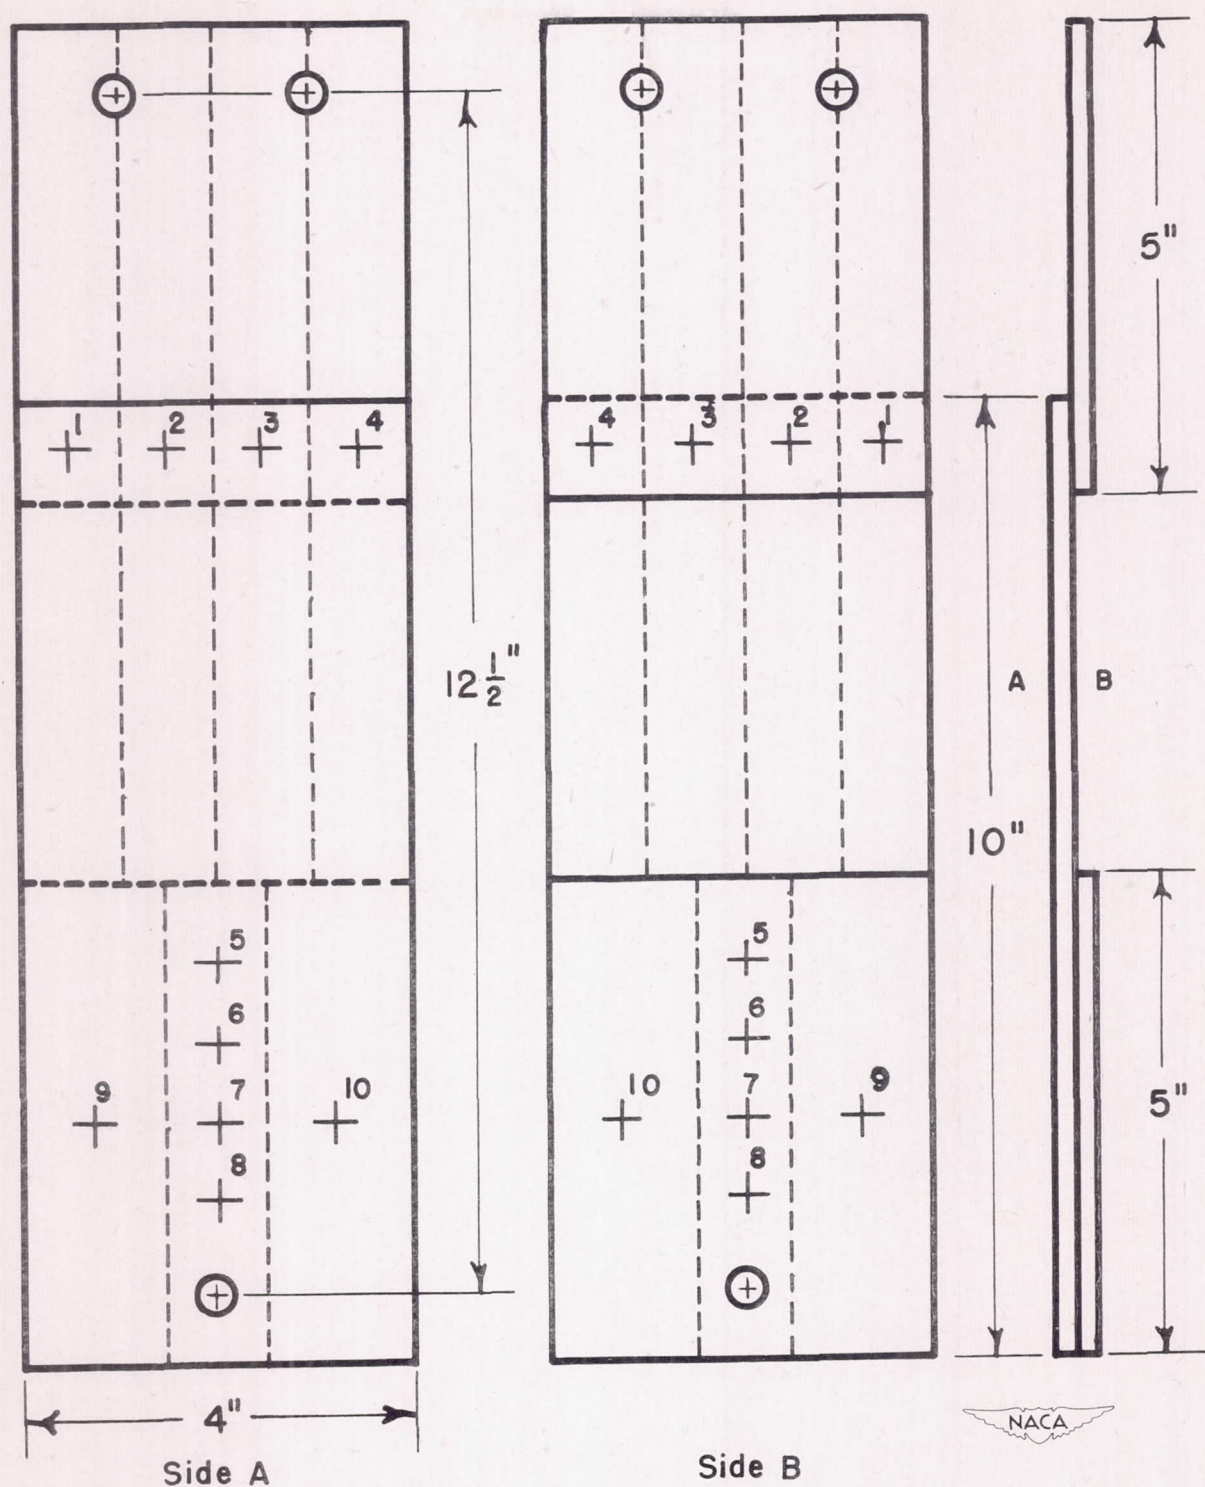
Figure 1.- Design for test panels of spot-welded aluminum alloys.  
Numbers indicate location of welds.

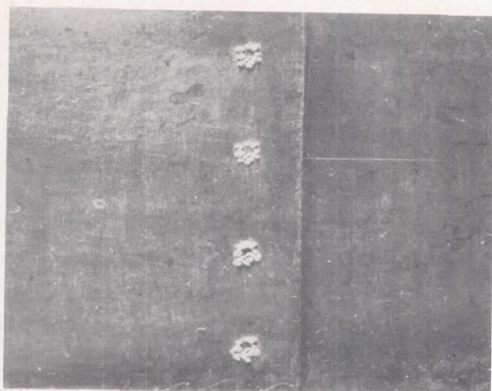
B     ring of corrosion products just inside circumference of weld as illustrated in figure 2

Figure 2.- Type B. Typical ring of corrosion products just inside circumference of welds,  $\times \frac{1}{2}$ .

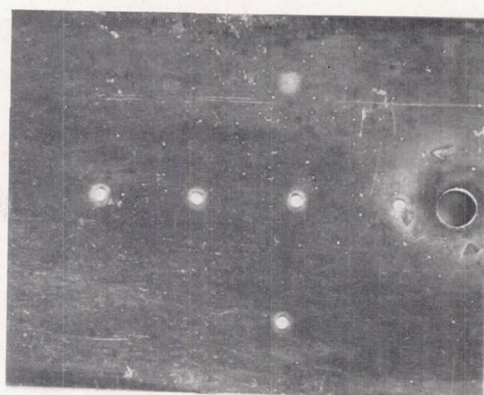
- C area of corrosion products in center of weld as illustrated in figure 3
- D corrosion products on circumference (rim of depressed area) of weld, a typical example of which is shown in figure 4

The alclad 24S-T3 panels were uncorroded after 2 days of exposure in the tidewater, except for the welds. Sound welds having 50-percent or less penetration (series 3) and welds made with dirty electrode tips (series 7) were unattacked. Corrosion products were found at the centers of some welds on panels welded so as to leave high residual stresses (series 4); panels with cracks visible on the surface of the welds (series 5); and panels with fins of weld metal expelled between the sheets (series 6), a typical example of which is shown in figure 3.

Figure 3.- Type C. Typical area of corrosion products in center of welds,  $\times \frac{1}{2}$ .

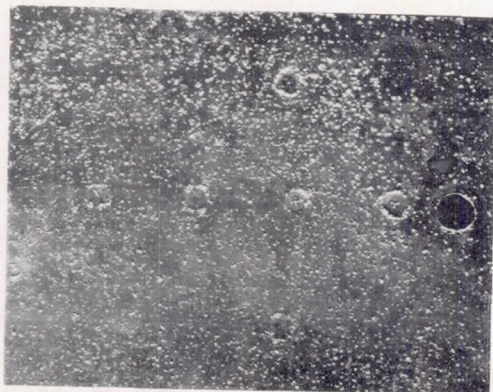
Figure 4.- Type D. Typical circumferential ring of corrosion products on rim of depressed area of weld,  $\times \frac{1}{2}$ .

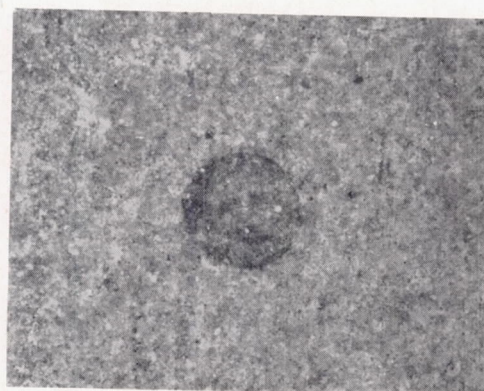
Figure 5.- Type E. Rough discolored ring inside weld, darker than main portion of panel,  $\times 3$ .

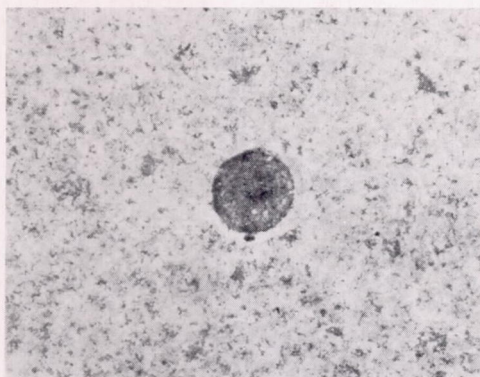
Figure 6.- Type F. Dark gray colored area in center of weld, darker than main portion of panel, X3.

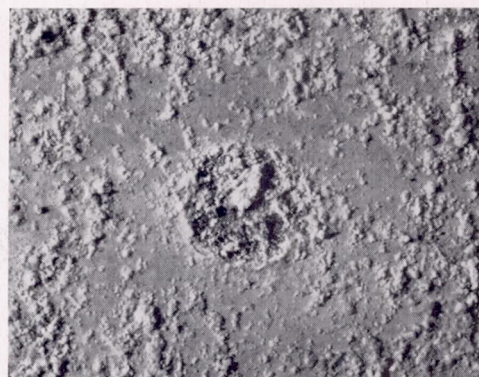
- G corrosion products general, that is, about equally distributed on the welds and the rest of the panel (This is illustrated in fig. 7, which is the earthward surface of a panel after 36 months of exposure in marine atmosphere. Skyward surfaces of panels, panels exposed in tidewater, and panels exposed for shorter periods of time (less than 36 months) were not necessarily as severely corroded as that shown in fig. 7, but uniformity of corrosive attack was about the same in each case.)

Figure 7.- Type G. Corrosion products are approximately as heavy on panel as they are on weld, X3.

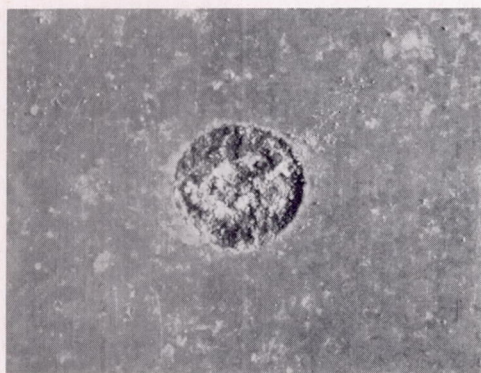
Figure 8.- Type J. General, severe corrosive attack on spot welds, X3.

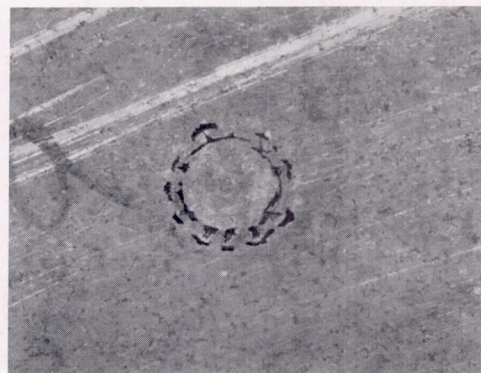
Figure 9.- Type K. "Pattern" corrosion on welds made with "poor" technique, X3.

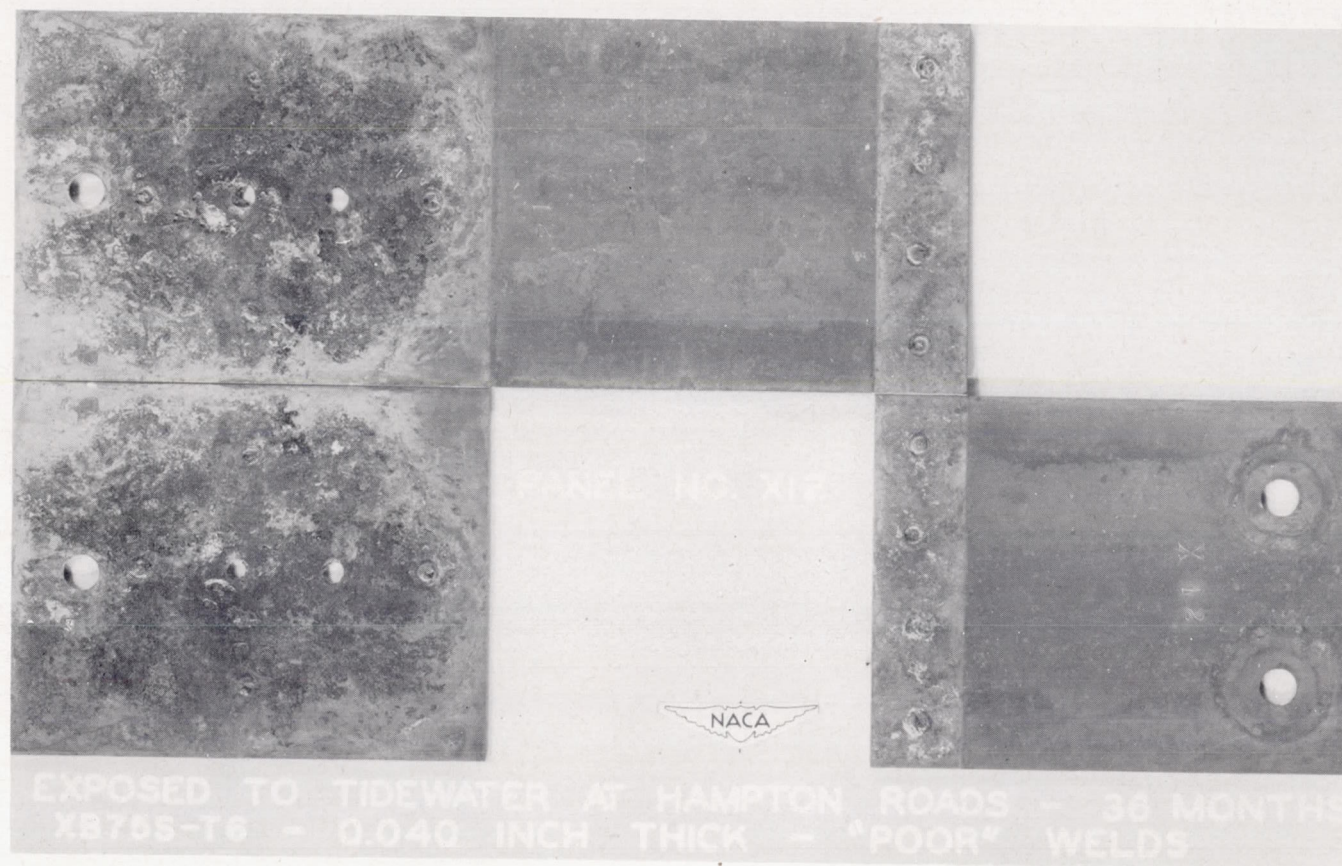
Figure 10.- Type L. Welds separated at faying surfaces by corrosive attack,  $\times \frac{1}{2}$ .

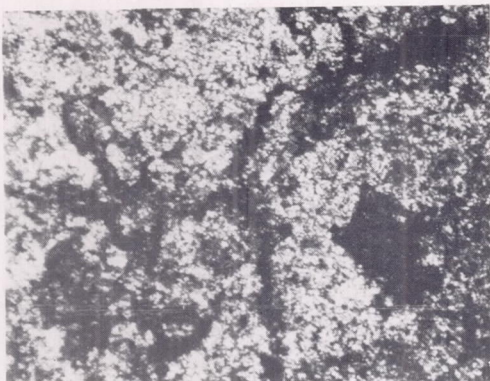
Figure 11.- Type N. Cracks representative of those found on surfaces of some welds, X50.

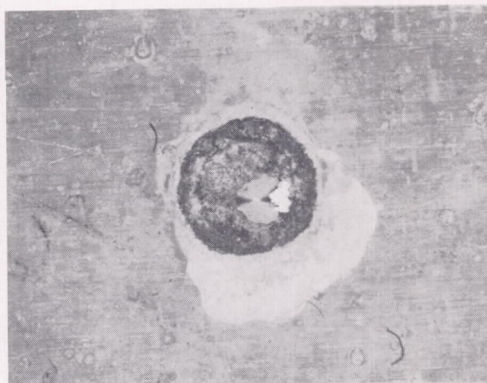
Figure 12.- Type P. Weld completely penetrated at one place and through one thickness of sheet in balance of weld, X3.

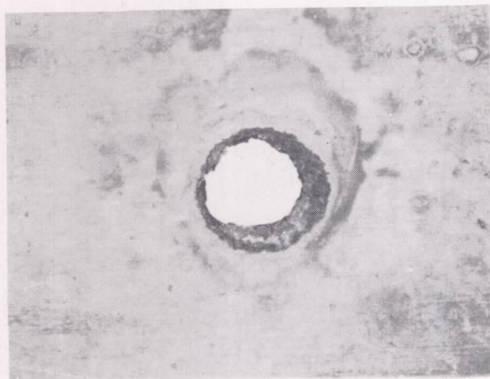
Figure 13.- Type P. Weld completely penetrated by corrosive attack, X3.

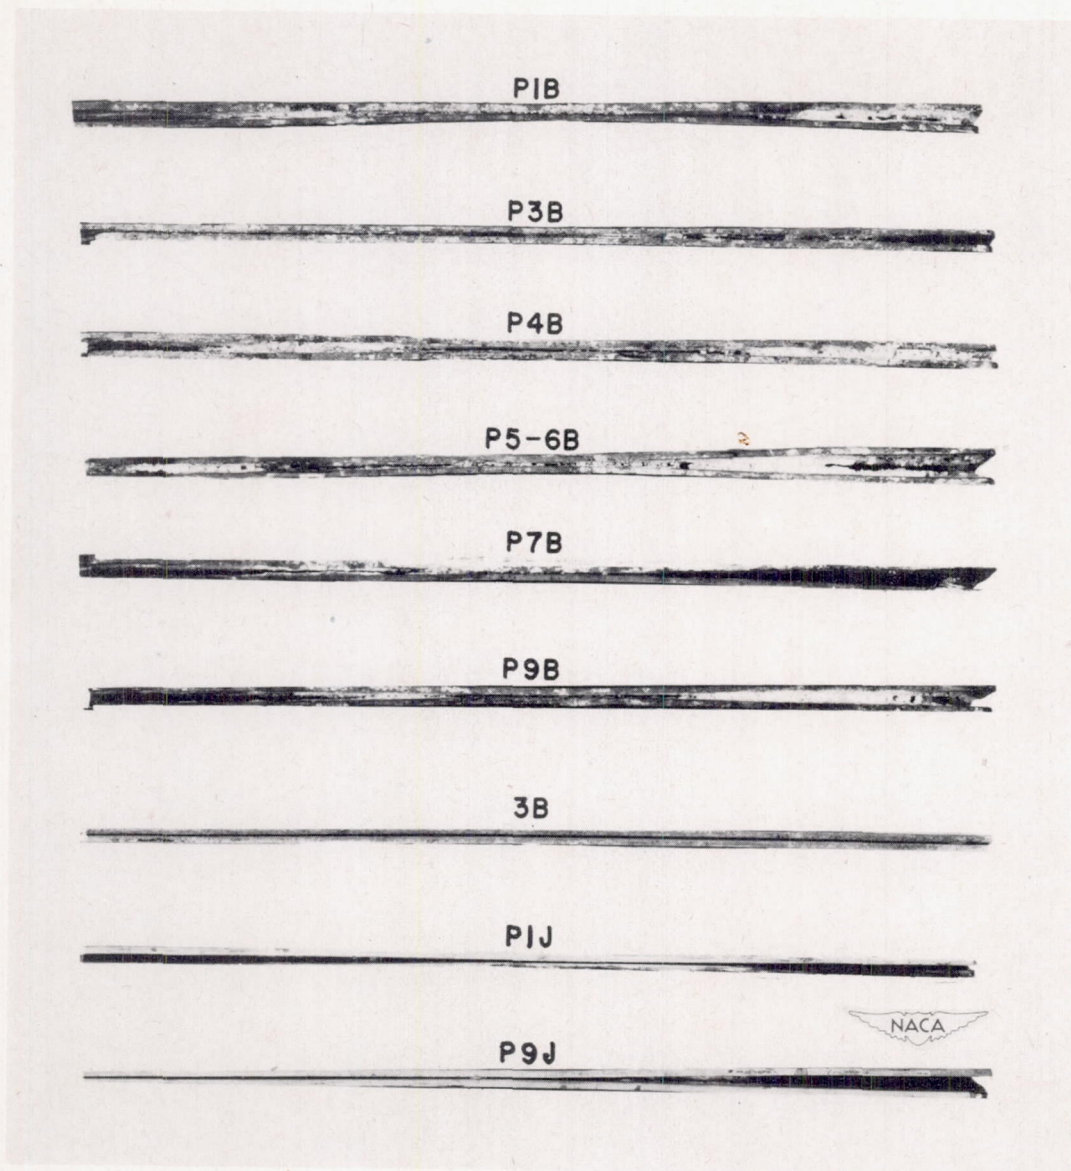
Figure 15.- Separation of sheets resulting from accumulation of corrosion products between faying surfaces, X1. Exposed in tidewater for 6 months. Panel 3B, alclad 24S-T3, was inserted for comparison purposes; no accumulation of corrosion products at faying surfaces.

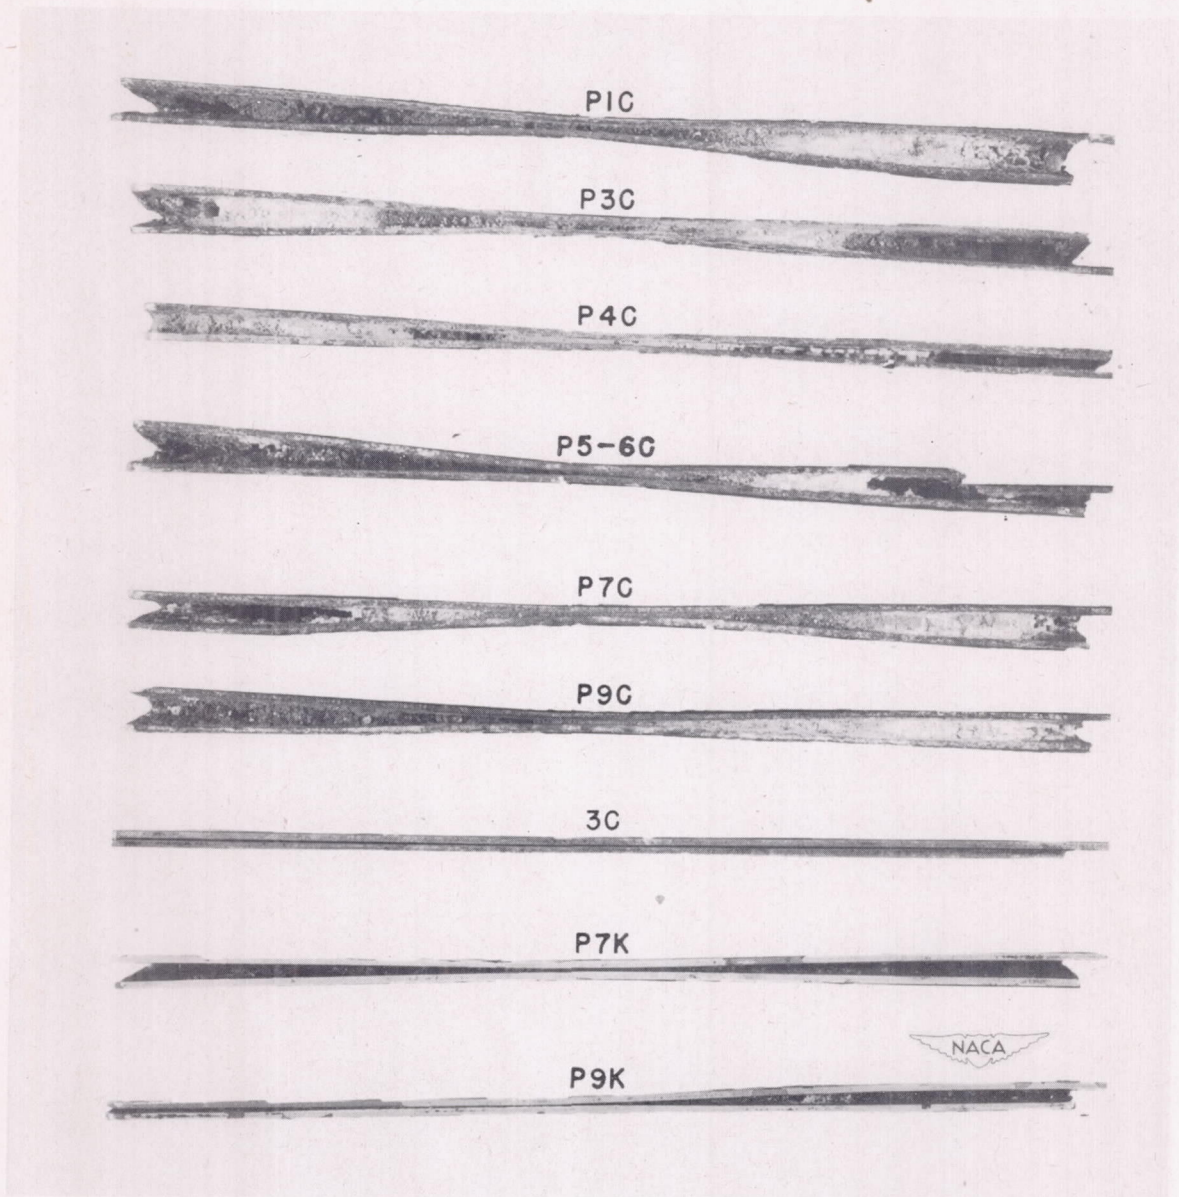
Figure 16.- Separation of sheets resulting from accumulation of corrosion products between faying surfaces, X1. Exposed in tidewater for 12 months. Panel 3C, alclad 24S-T3, was inserted for comparison purposes; no accumulation of corrosion products at faying surfaces.

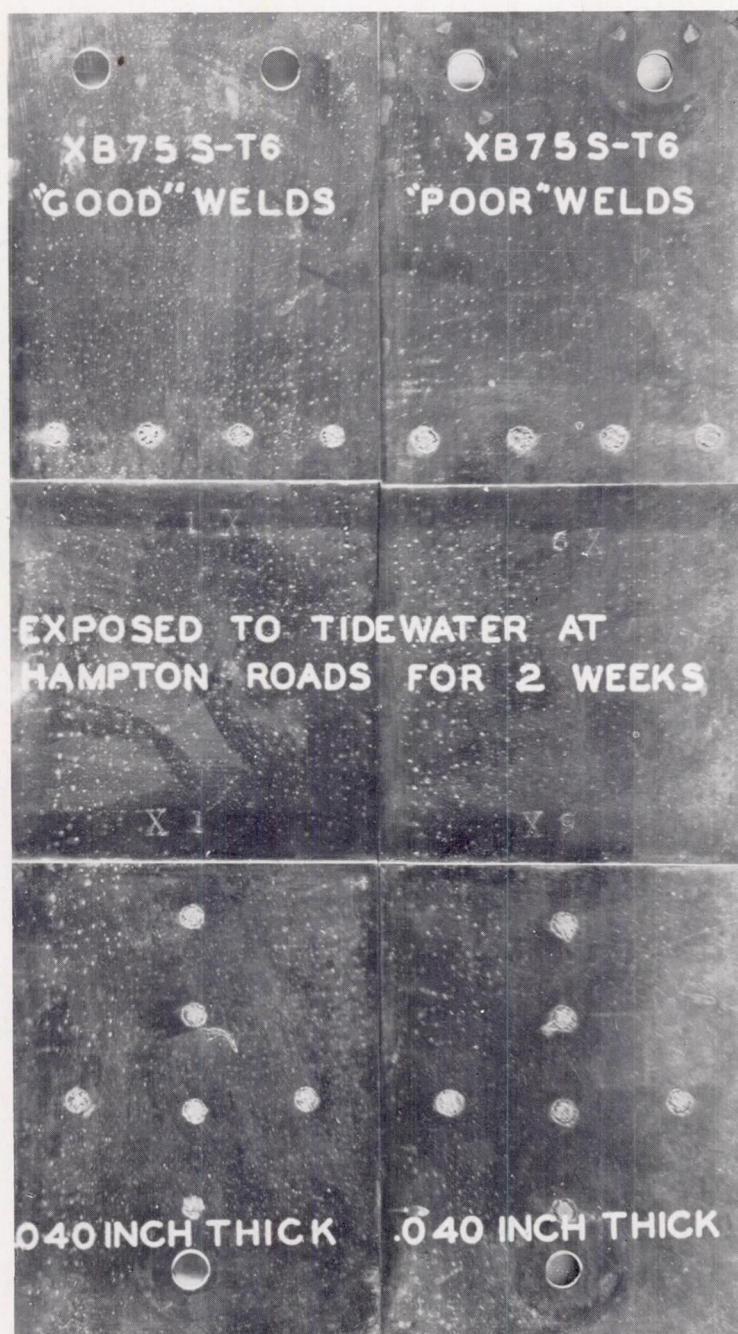
Figure 17.- Localized corrosion on spot welds made with both "good" and "poor" techniques,  $X\frac{1}{2}$ . Attack was almost as severe as shown here after 2 days of exposure to tidewater.

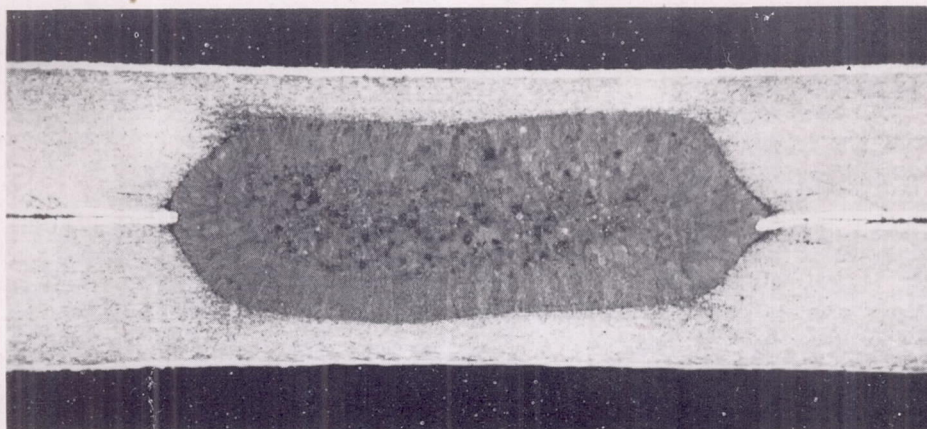
Figure 18.- Macrostructure of weld zone of sample 1C, alclad 24S-T3, exposed to tidewater for 1 year, X20. Keller's etch, 20 seconds. Weld structure was sound and uniformly distributed between two sheets. Structure was characteristic of group 1 samples which were welded under conditions to produce sound welds after chemical preparation of sheet surfaces.

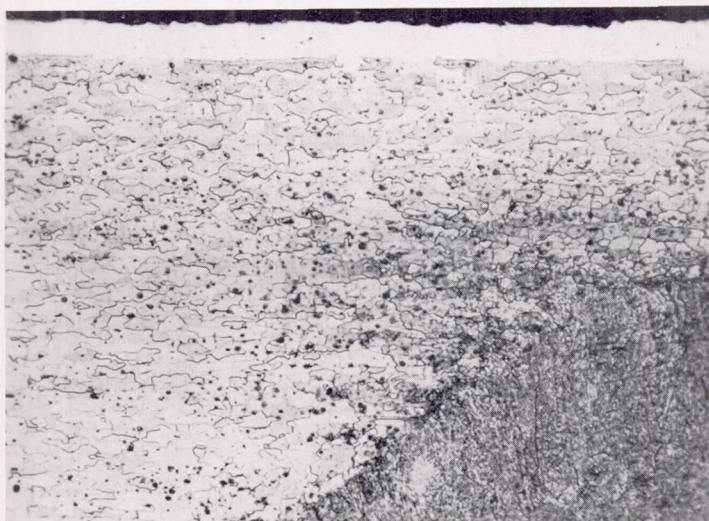
Figure 19.- Area from upper left corner of nugget shown in figure 18, X100. Keller's etch, 20 seconds. No significant extent of corrosion attack was observed on this sample.

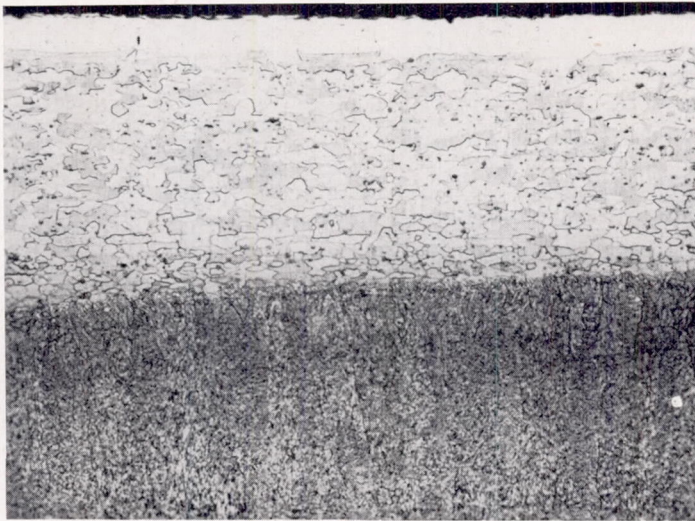
Figure 20.- Typical appearance of portion of nugget, core, and clad regions in sample 1G, alclad 24S-T3 sheet, exposed 3 years to laboratory atmosphere, X100. Keller's etch, 20 seconds. No evidence of corrosion attack on this sample.

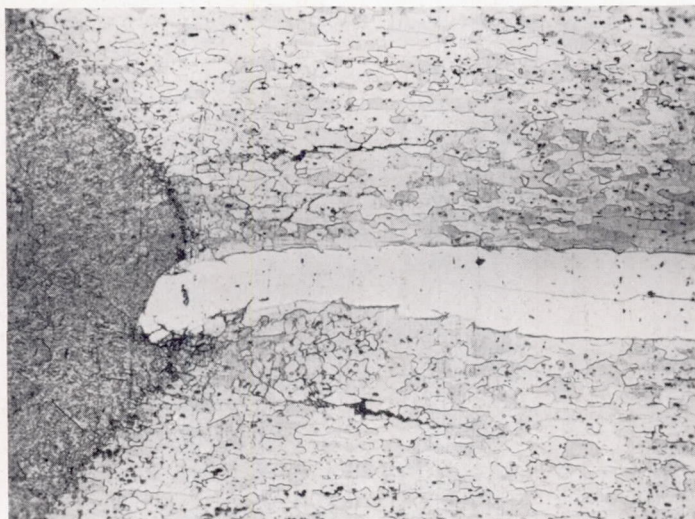
Figure 21.- Nugget-faying surface interface of sample shown in figure 20, X100. Keller's etch, 20 seconds. Structure was typical of appearance of alclad 24S-T3 samples examined in this study. Note continuation of higher-melting 2S clad into nugget zone and intrusion of eutectic into core structure above and below cladding.

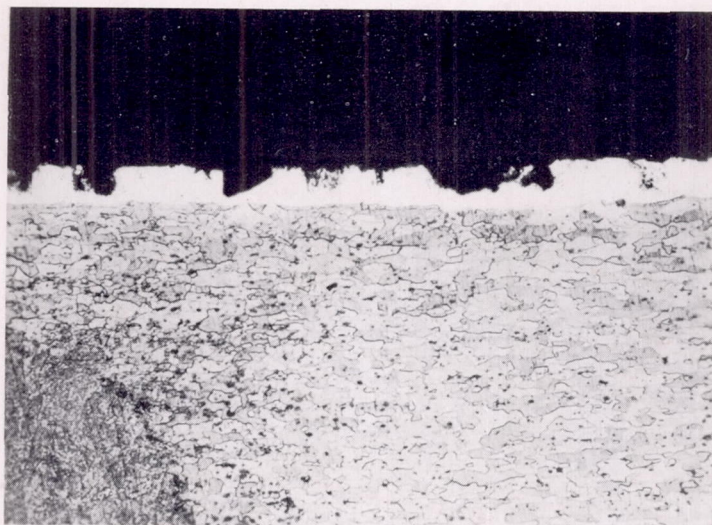
Figure 22.- Most severe degree of pitting type of corrosion attack on sample 1E, alclad 24S-T3, exposed 3 years to a sea coast atmosphere, X100. Keller's etch, 20 seconds. Attack was concentrated near weld zone and did not penetrate cladding.

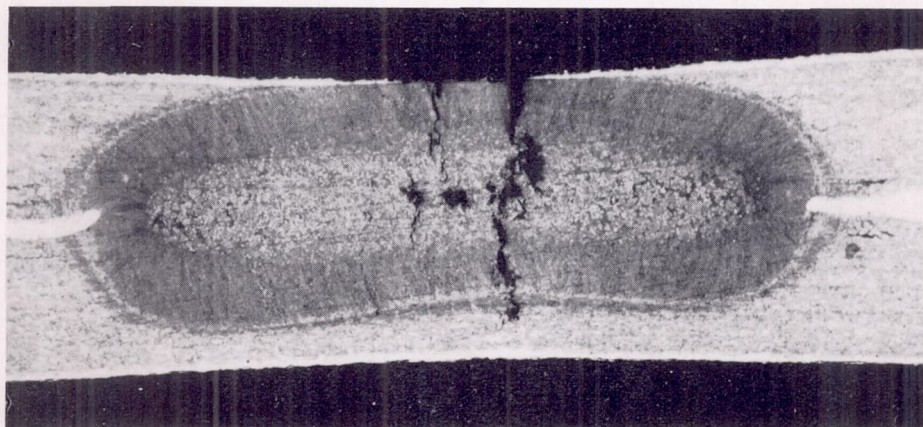
Figure 23.- Macrostructure of sample 5C, alclad 24S-T3, welded under conditions to produce cracking to surface and exposed 1 year to tidewater, X20. Keller's etch, 20 seconds. Nugget has absorbed portion of cladding on one surface. See figure 24.

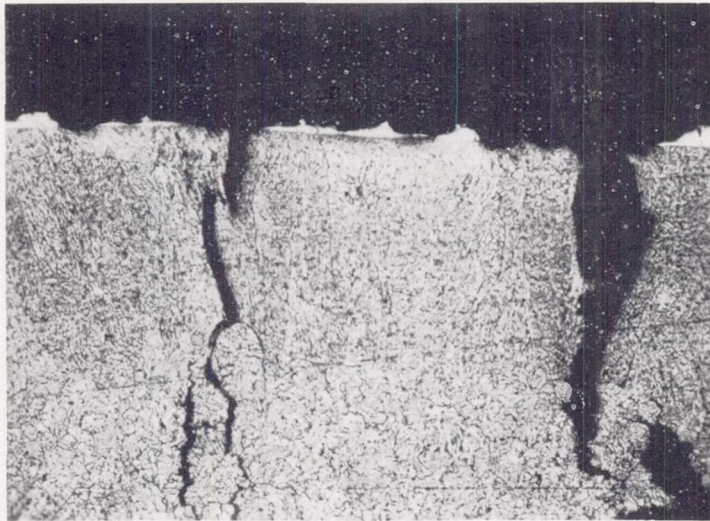
Figure 24.- Area from the top-center surface of weld shown in figure 23, X100. Keller's etch, 20 seconds. Note that tiny fragments of cladding have remained to provide effective cathodic protection for underlying core.

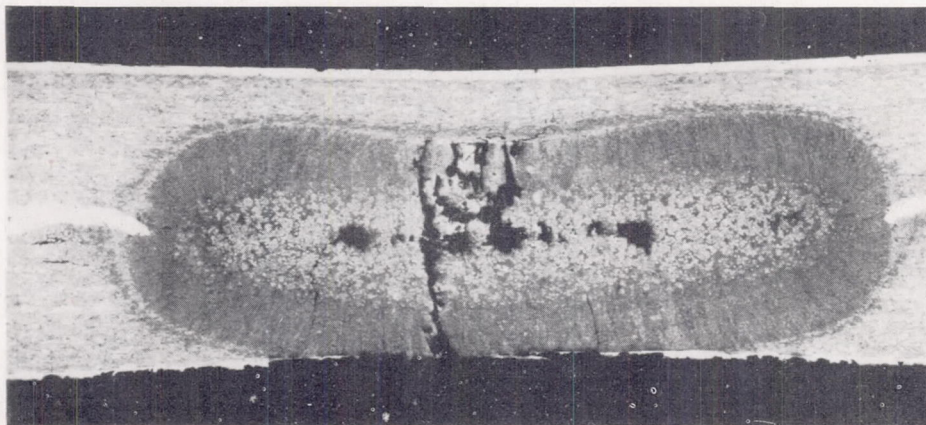
Figure 25.- Macrostructure of sample 5F, alclad 24S-T3, exposed 3 years to sea coast atmosphere after welding to produce cracks to surface, X20. Keller's etch, 20 seconds. Compare with figure 23. Note corrosion attack in cladding in vicinity of weld along bottom.

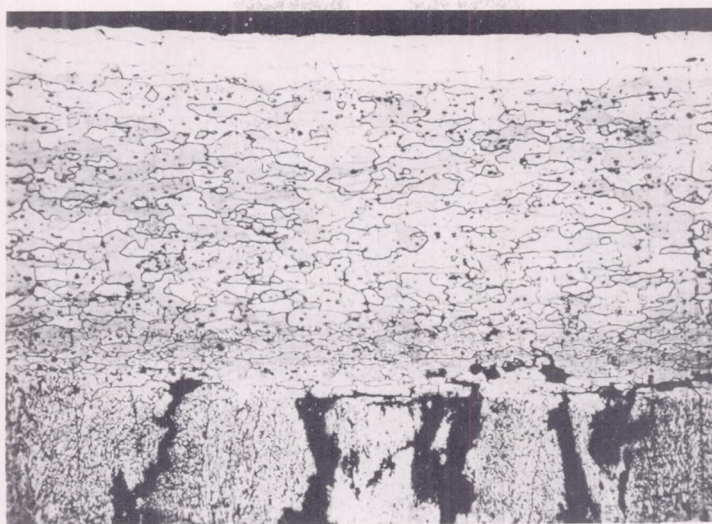
Figure 26.- Area from top center of figure 25 showing no significant extent of corrosion attack on surface, X100. Keller's etch, 20 seconds. Lower side of weld in figure 25 was similar in appearance to figure 24.

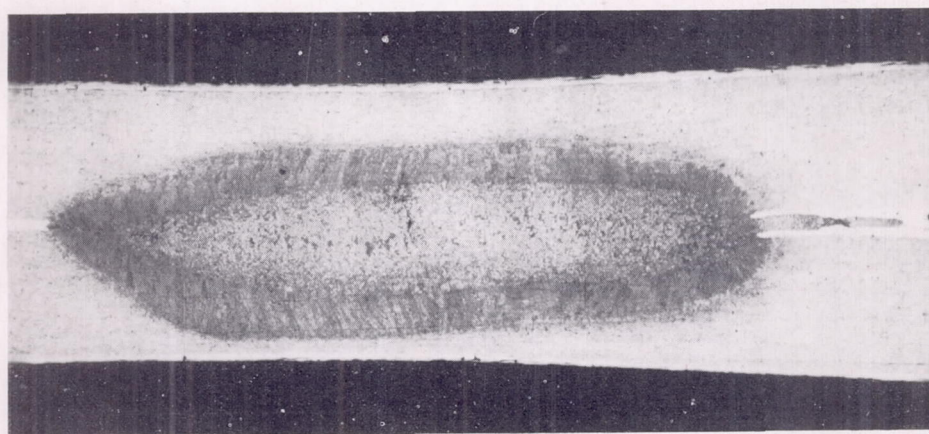
Figure 27.- Example of expulsion between faying surfaces of sample 6C, alclad 24S-T3, welded under conditions to induce expulsion and exposed 1 year to tidewater, X20. Keller's etch, 20 seconds.

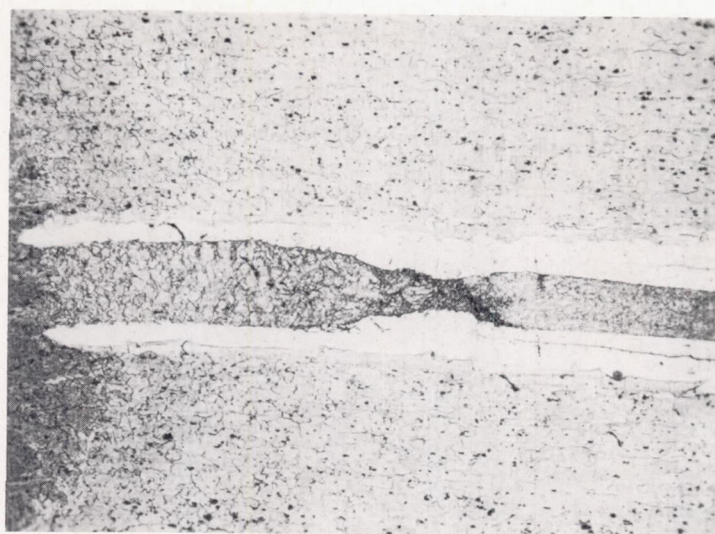
Figure 28.- Area of expelled metal showing retention of layer of cladding on either side, X100. Keller's etch, 20 seconds. No evidence of corrosion attack associated with this condition.

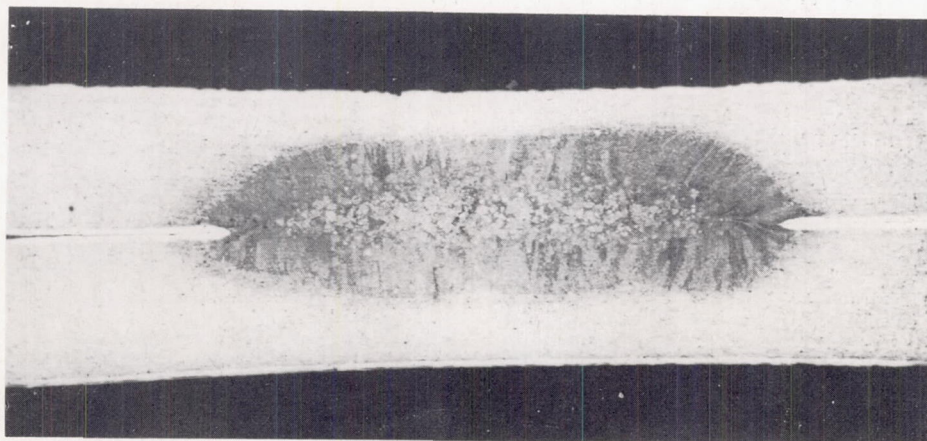
Figure 29.- Macrostructure of sample 6F, alclad 24S-T3, welded under conditions to produce expulsion and exposed 3 years in sea coast weather, X20. Keller's etch, 20 seconds.

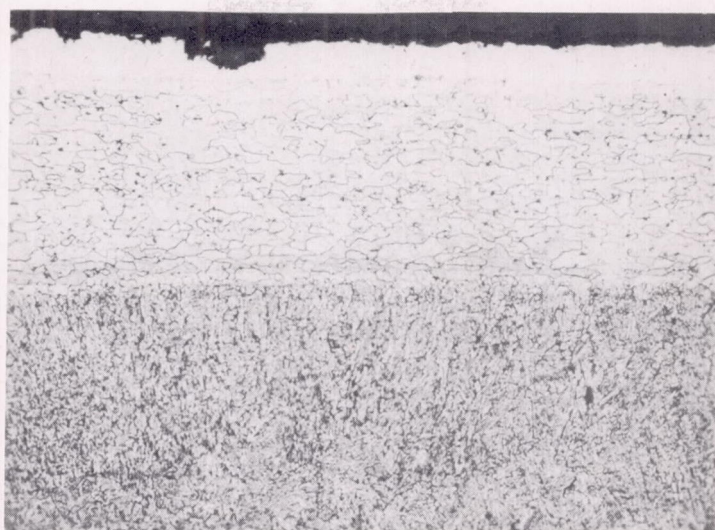
Figure 30.- Most severe degree of corrosion attack found in this specimen did not penetrate cladding. Area is from top center of figure 29, X100. Keller's etch, 20 seconds. No significant extent of attack on sheet away from weld zone. Note fine cracks in lower left corner in nugget structure.

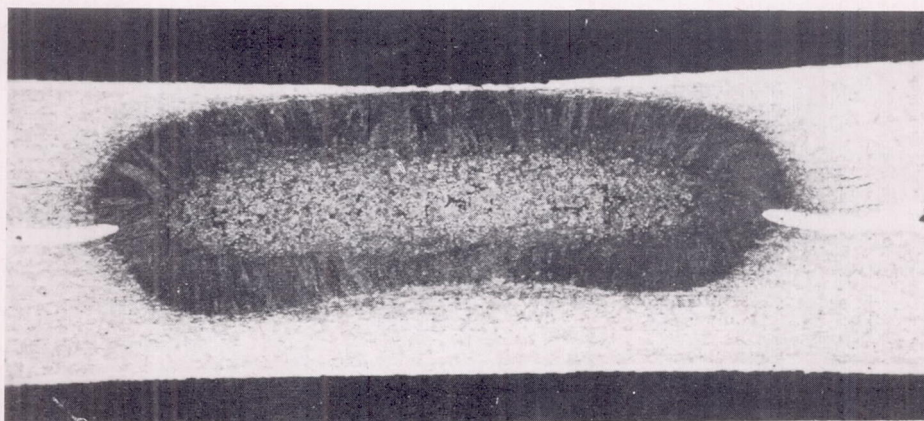
Figure 31.- Sample 9C, alclad 24S-T3, welded under conditions to produce a sound weld after wire-brush preparation. Nugget penetrated entirely to the cladding, X20. Keller's etch, .20 seconds.

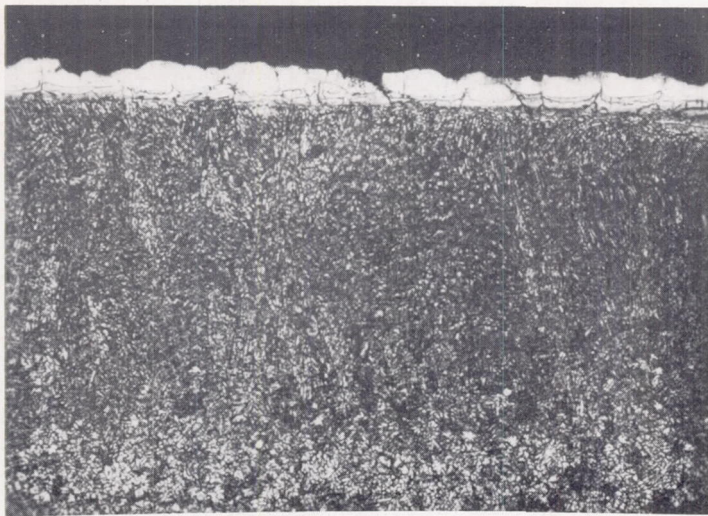
Figure 32.- Region from top center of figure 31 showing pronounced extent of diffusion of copper into cladding and evidence of corrosion attack, X100. Keller's etch, 20 seconds. As shown in figure 31, attack was confined to small area where nugget approached sheet surface.

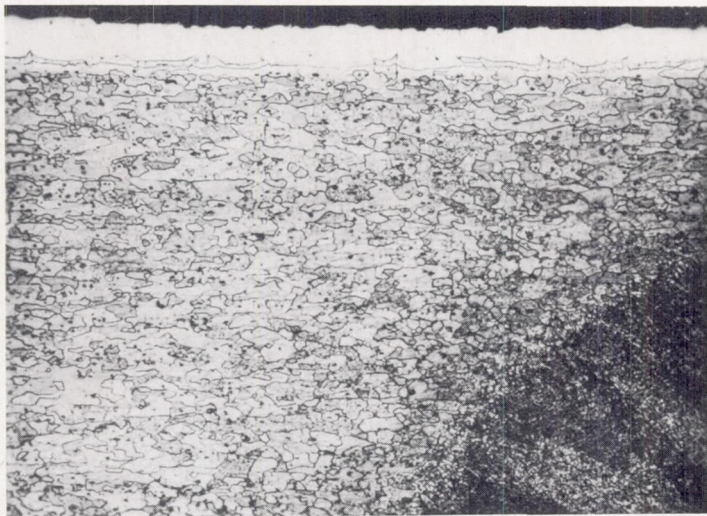
Figure 33.- General condition of diffusion of copper into cladding, typical of appearance in all parts of sheet. Area is from upper left corner of nugget in figure 31, X100. Keller's etch, 20 seconds. No significant extent of corrosion was observed.

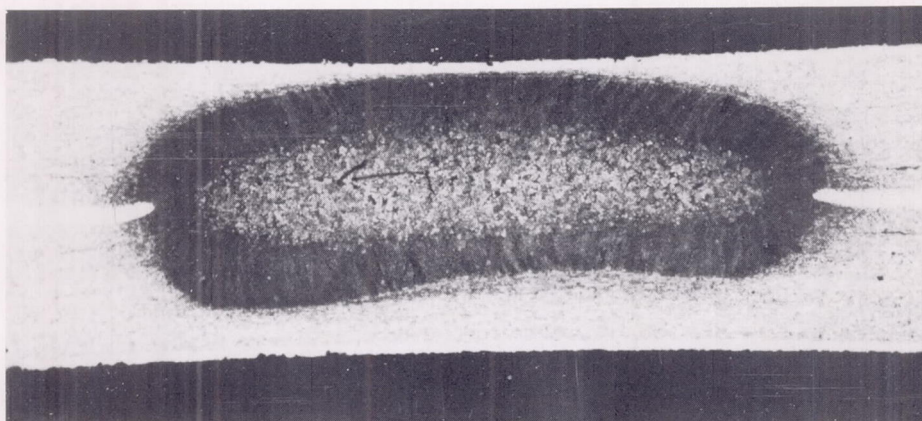
Figure 34.- Macrograph showing weld nugget slightly below clad surface in sample 9F, alclad 24S-T3, welded under conditions to produce a sound weld after wire-brush preparation and exposed 3 years to sea coast atmosphere, X20. Keller's etch, 20 seconds. Compare with figure 31.

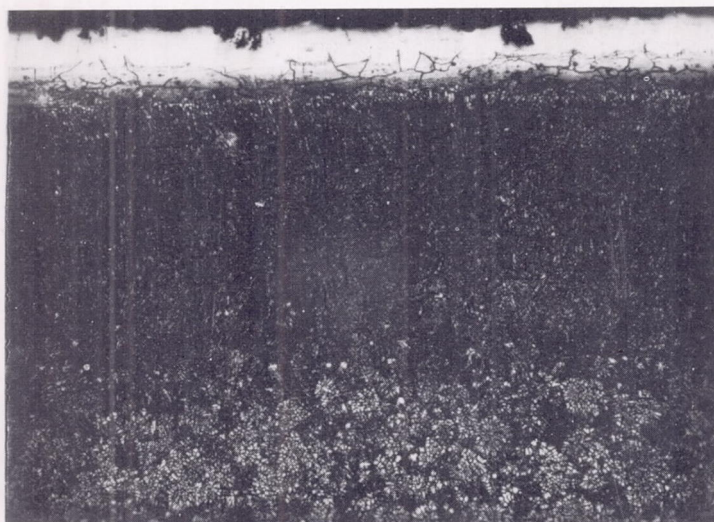
Figure 35.- Area from top center of figure 34 showing some evidence of diffusion of copper into cladding but less pronounced than in figure 32, X100. Keller's etch, 20 seconds. General condition of surface attack throughout sample, not accelerated in vicinity of weld.

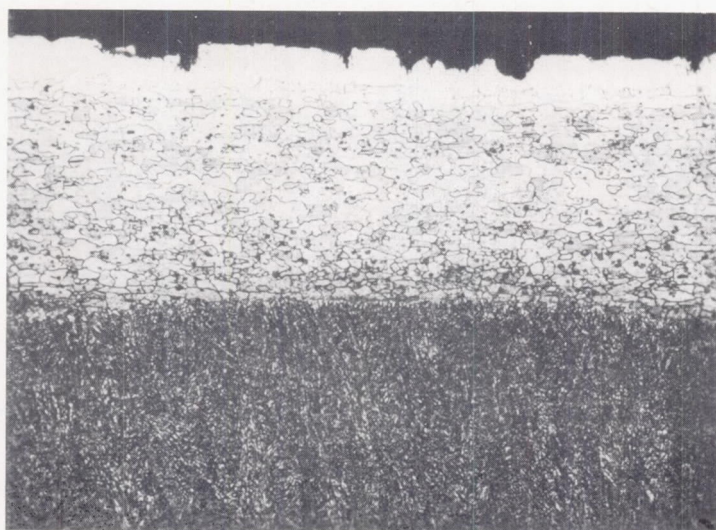
Figure 36.- Extent of surface attack on opposite side of sheet from region in figure 35, X100. Keller's etch, 20 seconds. Attack penetrated over half of cladding thickness, but was not greater in extent than in other parts of sheet surface away from weld.

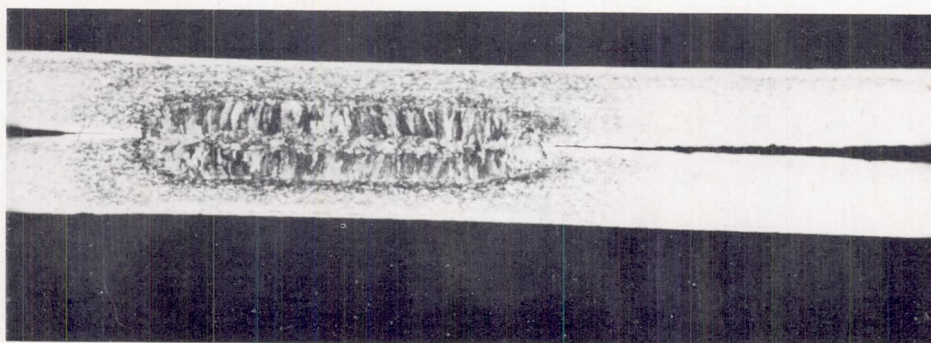
Figure 37.- Macrostructure of sample 2R<sub>4</sub>, R-301-T6, welded to produce a sound structure after chemical preparation of sheet and exposed 3 years in tidewater, X20. Keller's etch, 20 seconds.

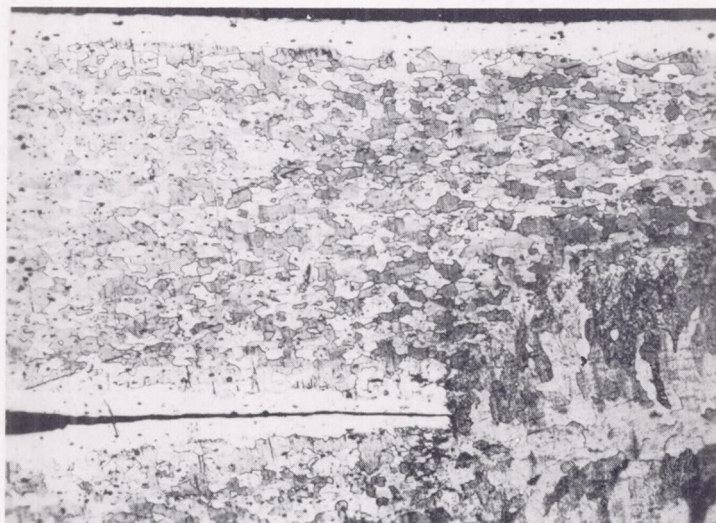
Figure 38.- No significant extent of attack was observed on outer or faying surfaces of sample 2R<sub>4</sub>. Dark areas in cladding alloy are constituent particles, X100. Keller's etch, 20 seconds.

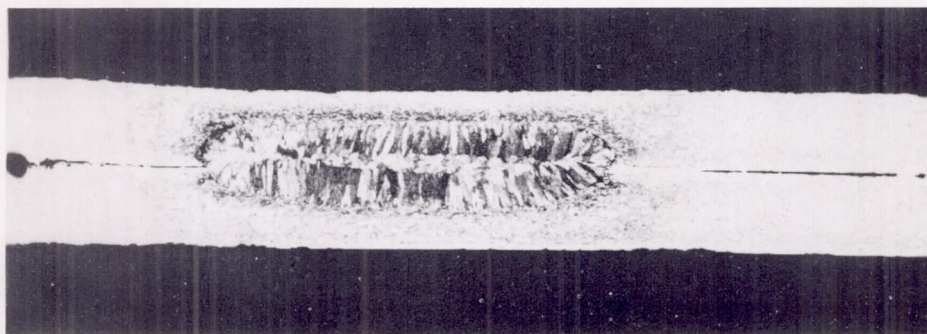
Figure 39.- Macrostructure of sample 2R<sub>6</sub>, R-301-T6, welded to produce a sound structure after chemical preparation and exposed 3 years to sea coast atmosphere, X20. Keller's etch, 30 seconds.

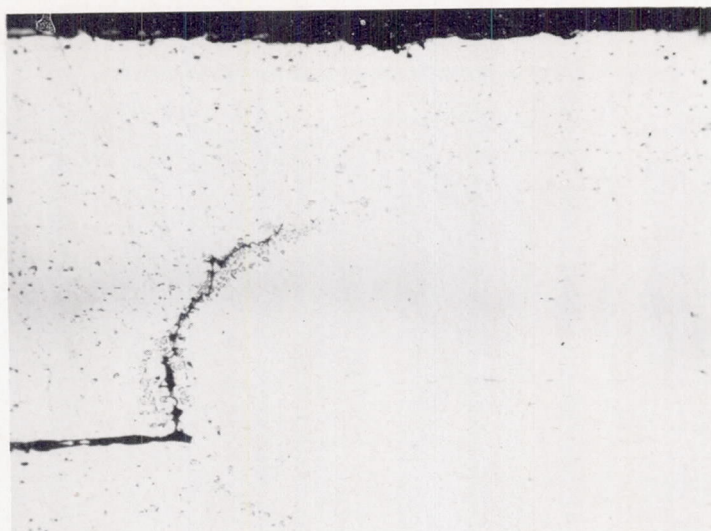
Figure 40.- Typical appearance of envelope of constituent particles segregated along periphery of weld nugget, X100. Unetched. This condition was characteristic of R-301-T6 sheet welds, was observed in XB75S-T6 welds, but not apparent in alclad 24S-T3 welds. Identity of constituents was not established completely but from etching characteristics it was believed that they were of the insoluble aluminum-copper-iron-manganese phase. The crack, possibly formed during specimen preparation, illustrated susceptibility of the condition to propagation of fracture.

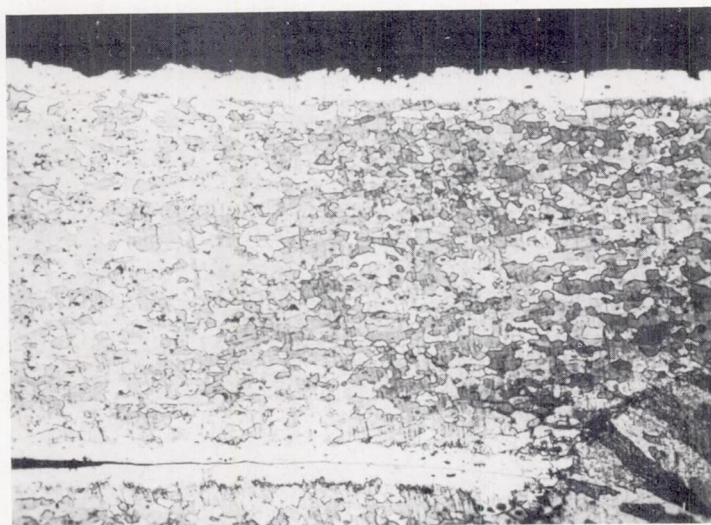
Figure 41.- Example of general type of corrosion observed on outer and inner surfaces of sample 2R6 in all parts of sample, X100. Keller's etch, 30 seconds.

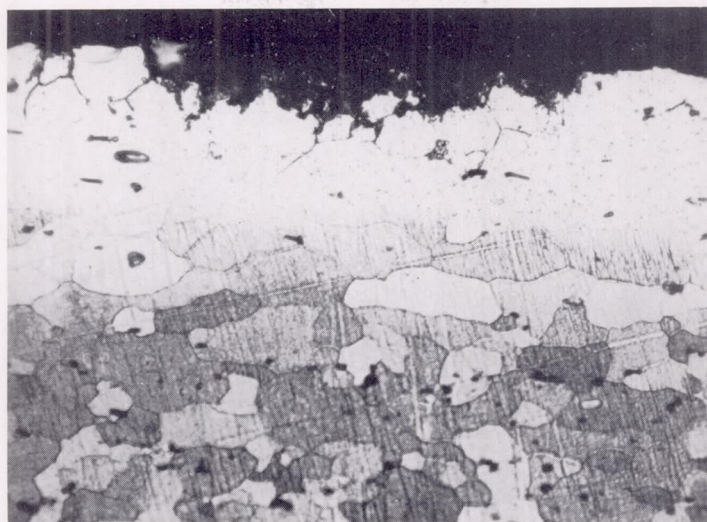
Figure 42.- Example of general type of corrosion observed on outer and inner surfaces of sample 2R6 in all parts of sample, X500. Keller's etch, 30 seconds. Attack appeared to be predominantly intergranular but had not penetrated coating.

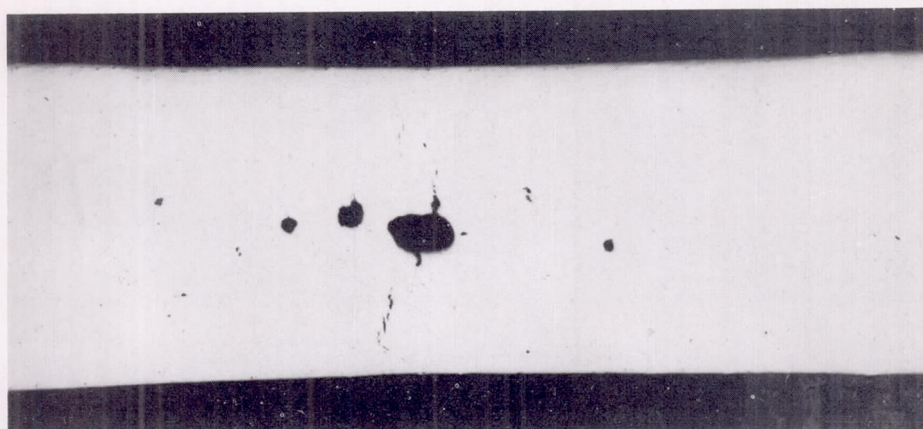
Figure 43.- Cracks to surface and general unsound weld structure of sample X-15, XB75S-T6, welded with dirty electrodes and exposed 3 years to laboratory atmosphere, X20. Unetched.

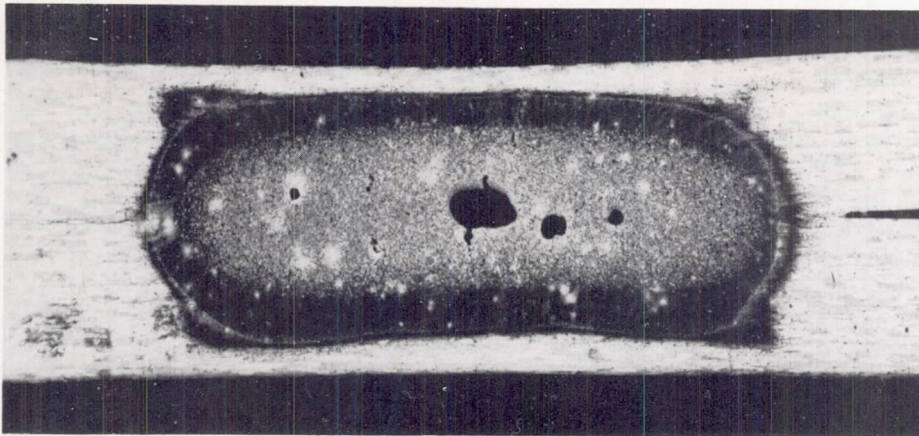
Figure 44.- Etched appearance of sample X-15, X20. Keller's etch, 30 seconds. No distinct evidence of corrosion attack was observed.

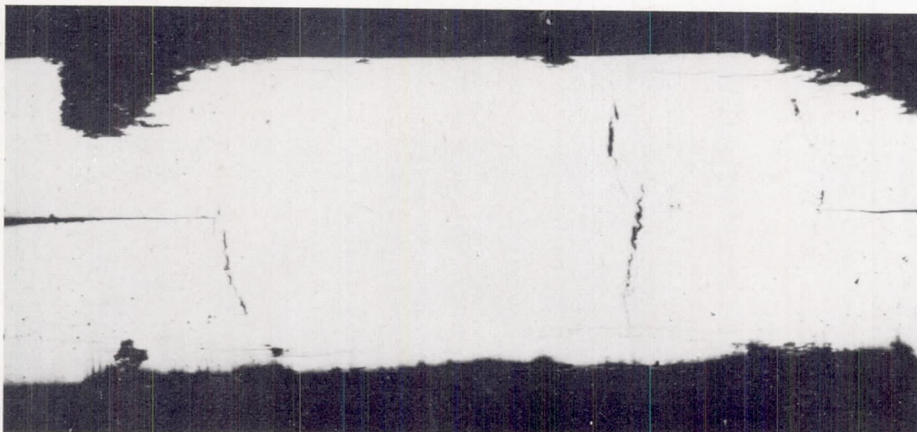
Figure 45.- Extremely severe intergranular corrosion attack accelerated at periphery of electrode indentation of sample X-9, XB75S-T6, welded with dirty electrodes after chemical preparation of surfaces and exposed 12 days in tidewater, X20. Unetched. Note thin envelope of constituent particles along periphery of nugget, shown more distinctly in figure 47.

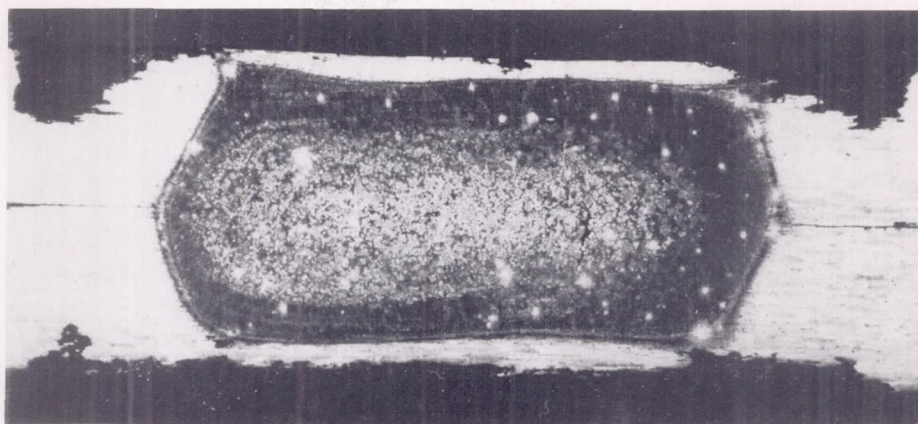
Figure 46.- Etched appearance of sample X-9, X20. Keller's etch, 20 seconds. Note intergranular attack along inner surface at extreme right.

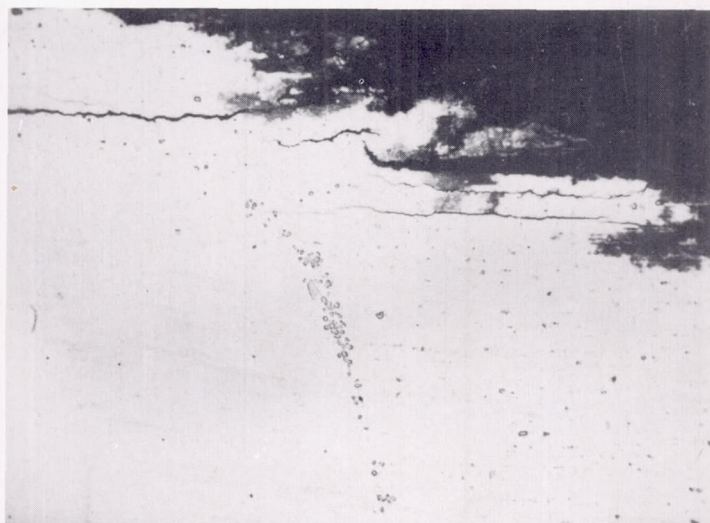
Figure 47.- Area from upper right corner of figure 45, X100. Unetched.
